Commonwealth of Massachusetts  
Department of Telecommunications and Energy  
Fitchburg Gas and Electric Light Company  
Docket No. D.T.E. 02-24/25  
Record Request Response

**Record Request No.: AG-RR-51**

**FG&E Electric Station Switchgear Failure  
March 12, 2000  
Event Analysis Report**

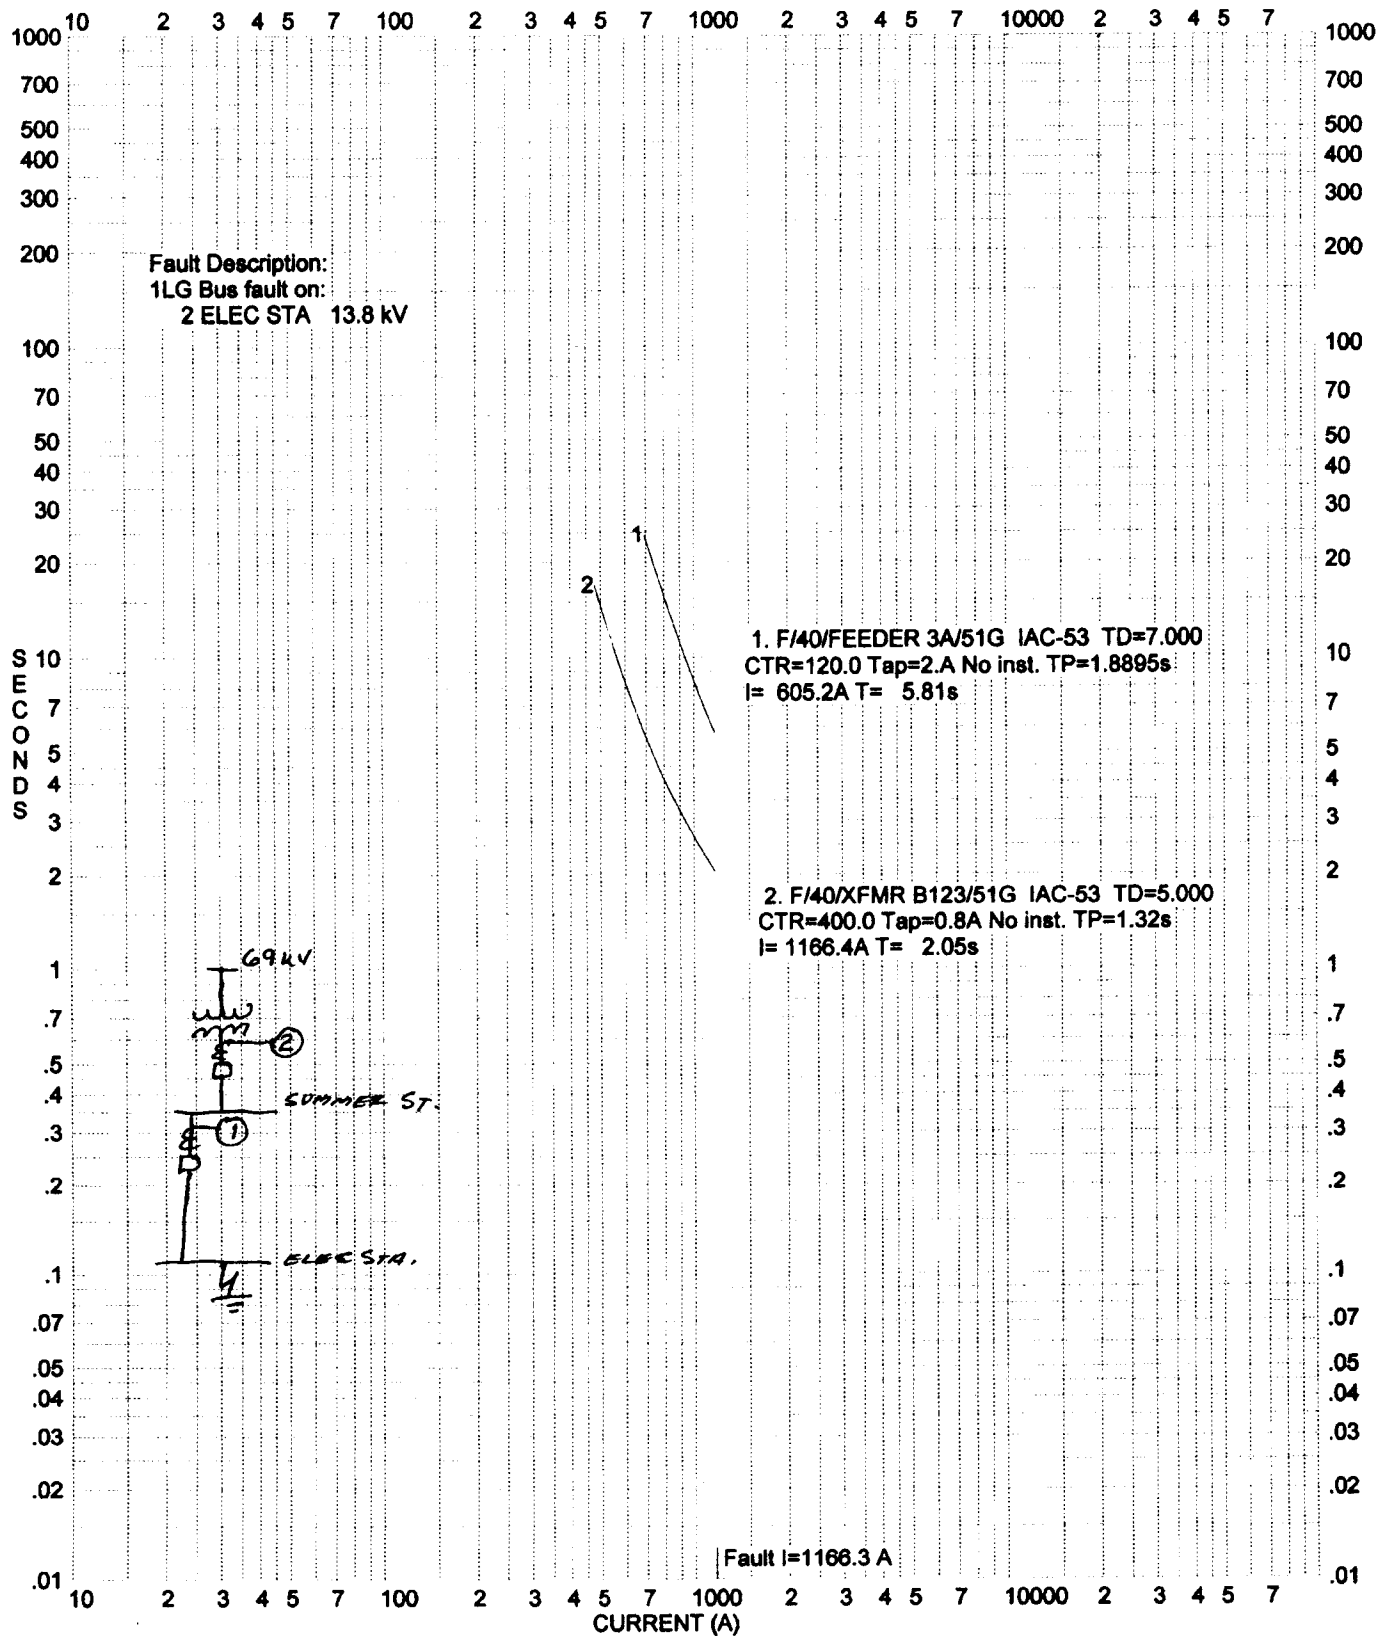
A coordination study revealed that the settings of the Transformer Neutral Overcurrent relays at Summer St. miscoordinate with the Neutral Overcurrent relays on Feeder 3A and Feeder 9. Appendix D show the time current curves of the present relay settings. The present settings of the Phase Overcurrent relays coordinate well.

TIME-CURRENT CURVES @ Voltage 13.8kV		By	JJB
For Coordination between Feeder 3A and Transf. Neut. OC at Summer St.		No.	1 Present
Comment Miscoordination Exists		Date	3/18/00

1. The settings of the Summer St. Transformer Phase and Neutral Overcurrent relays should be revised to coordinate with the 13.8kV feeder relays. The proposed settings are attached to this report as Appendix E.
2. The existing relays on Feeders 3A and 9 at Summer St. should be tested according to the relay setting test values attached in Appendix E of this report.
3. The Feeder 1A recloser was set with a temporary setting to allow the restoration of service. This recloser should be reset and tested per the setting sheet attached in Appendix E.
4. A relay coordination study should be performed for the Electric Station area.
5. Recommendations to reconfigure the system to a more permanent solution will be provided in a separate report. There will be additional recommendations to install other relays during this time.

Prior to reconfiguring the system, the Summer St. Transformer Neutral Overcurrent relays should be reset per the settings attached in Appendix E. The Feeder 3A and Feeder 9 relays should also be tested per the attached setting sheets.

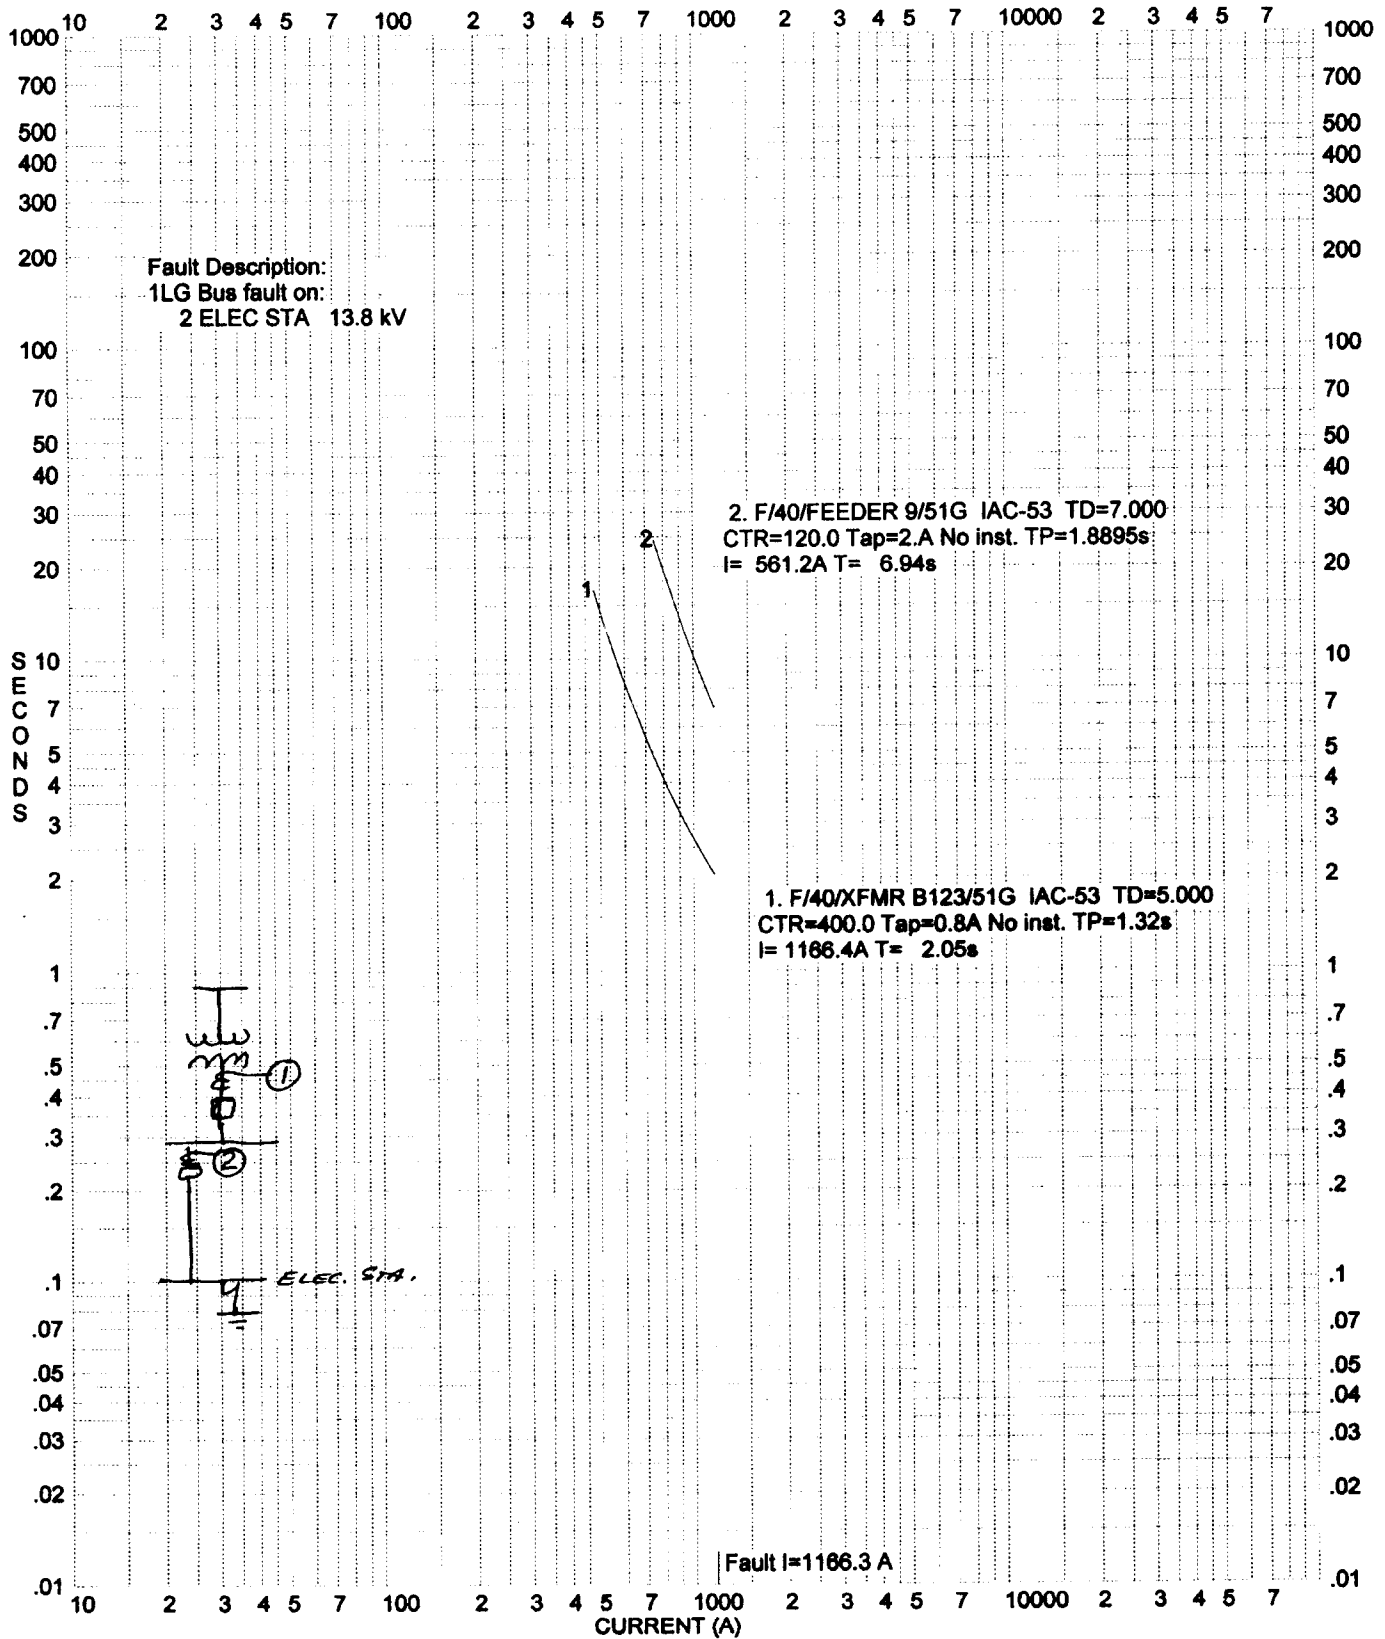
TIME-CURRENT CURVES @ Voltage 13.8kV		By JJB
For Coordination between Feeder 9 and Transf. Neut. OC at Summer St.		No. <u>2</u> Present
Comment Miscoordination Exists		Date 3/18/00

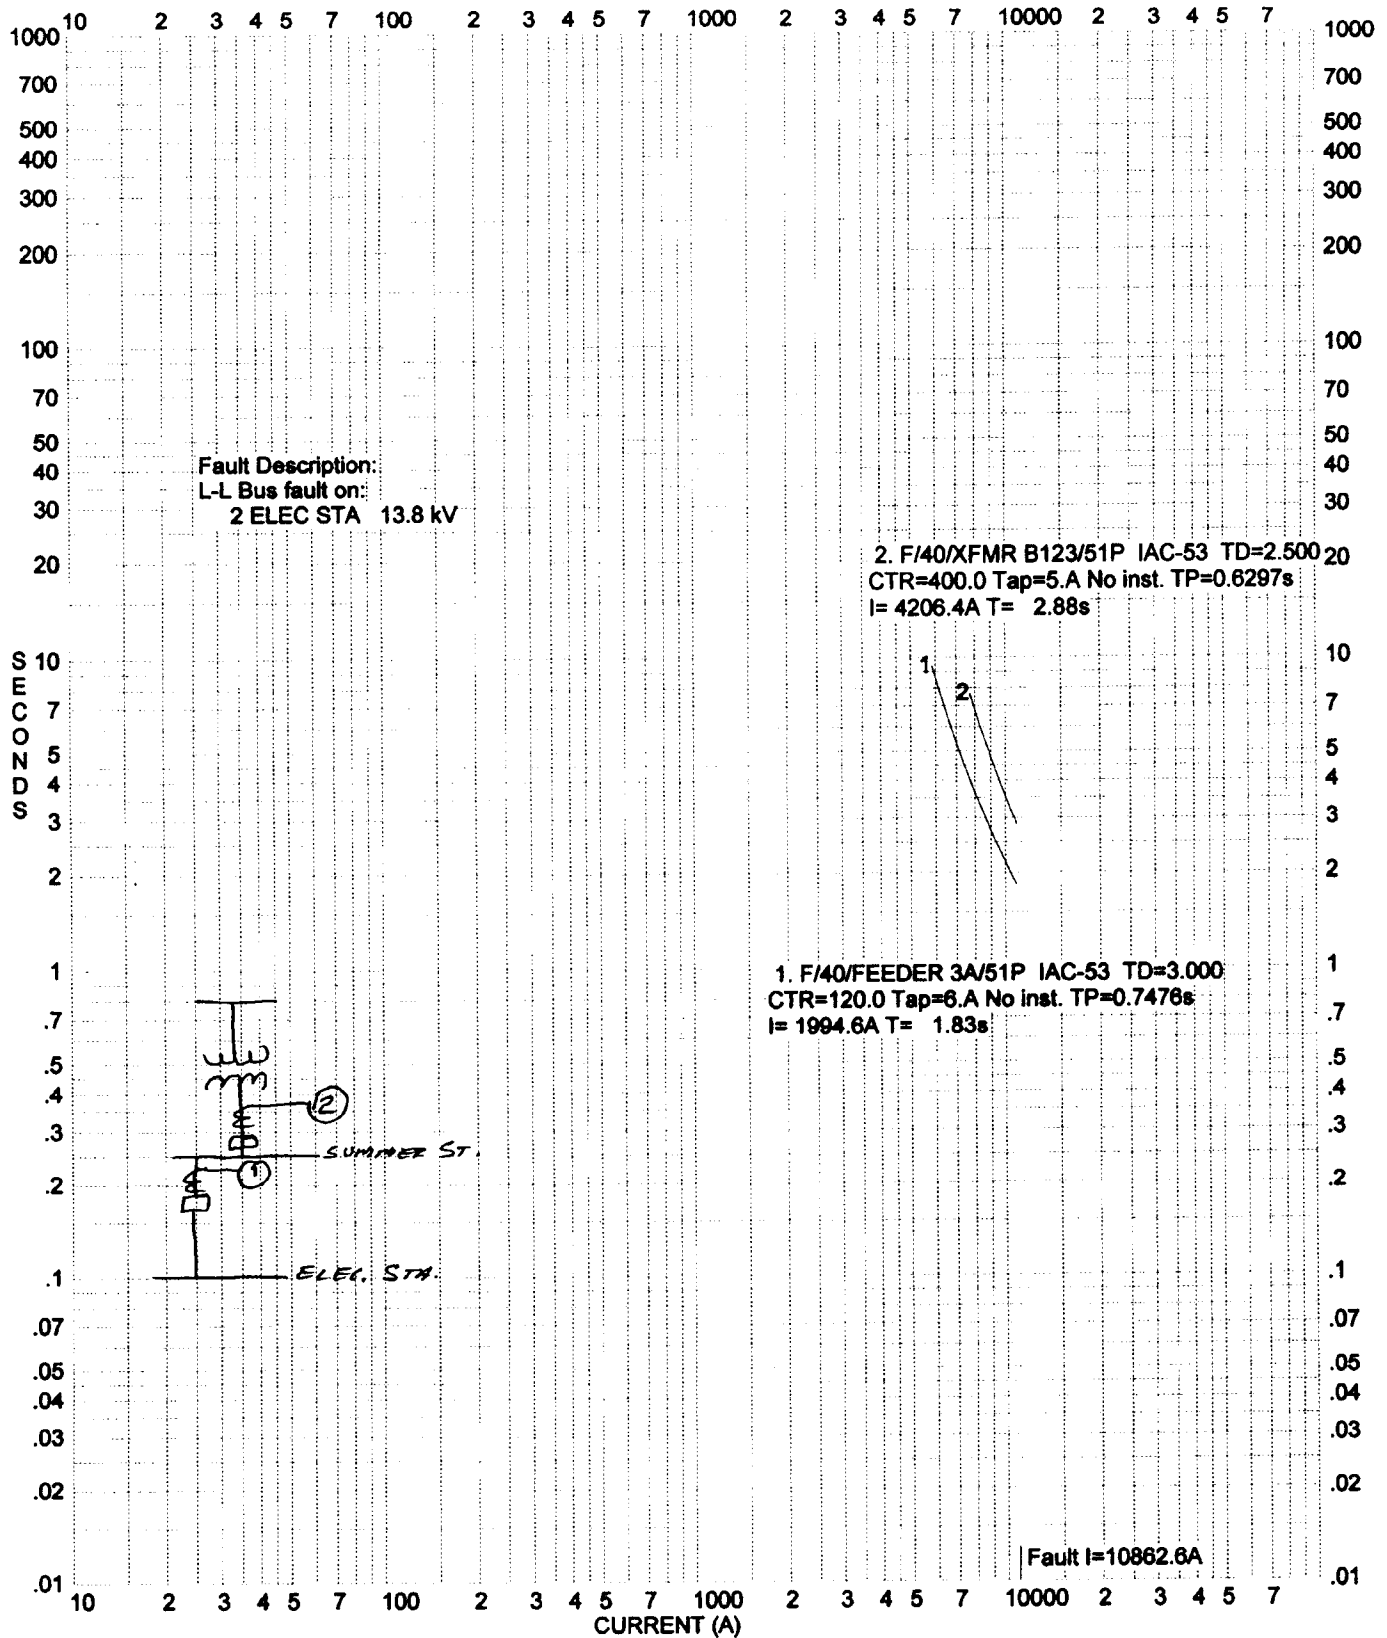
TIME-CURRENT CURVES @ Voltage 13.8kV		By	JJB
For Coordination between Feeder 3A and Transf. Phase OC at Summer St.		No.	3 Present
Comment Coordination Exists		Date	3/18/00

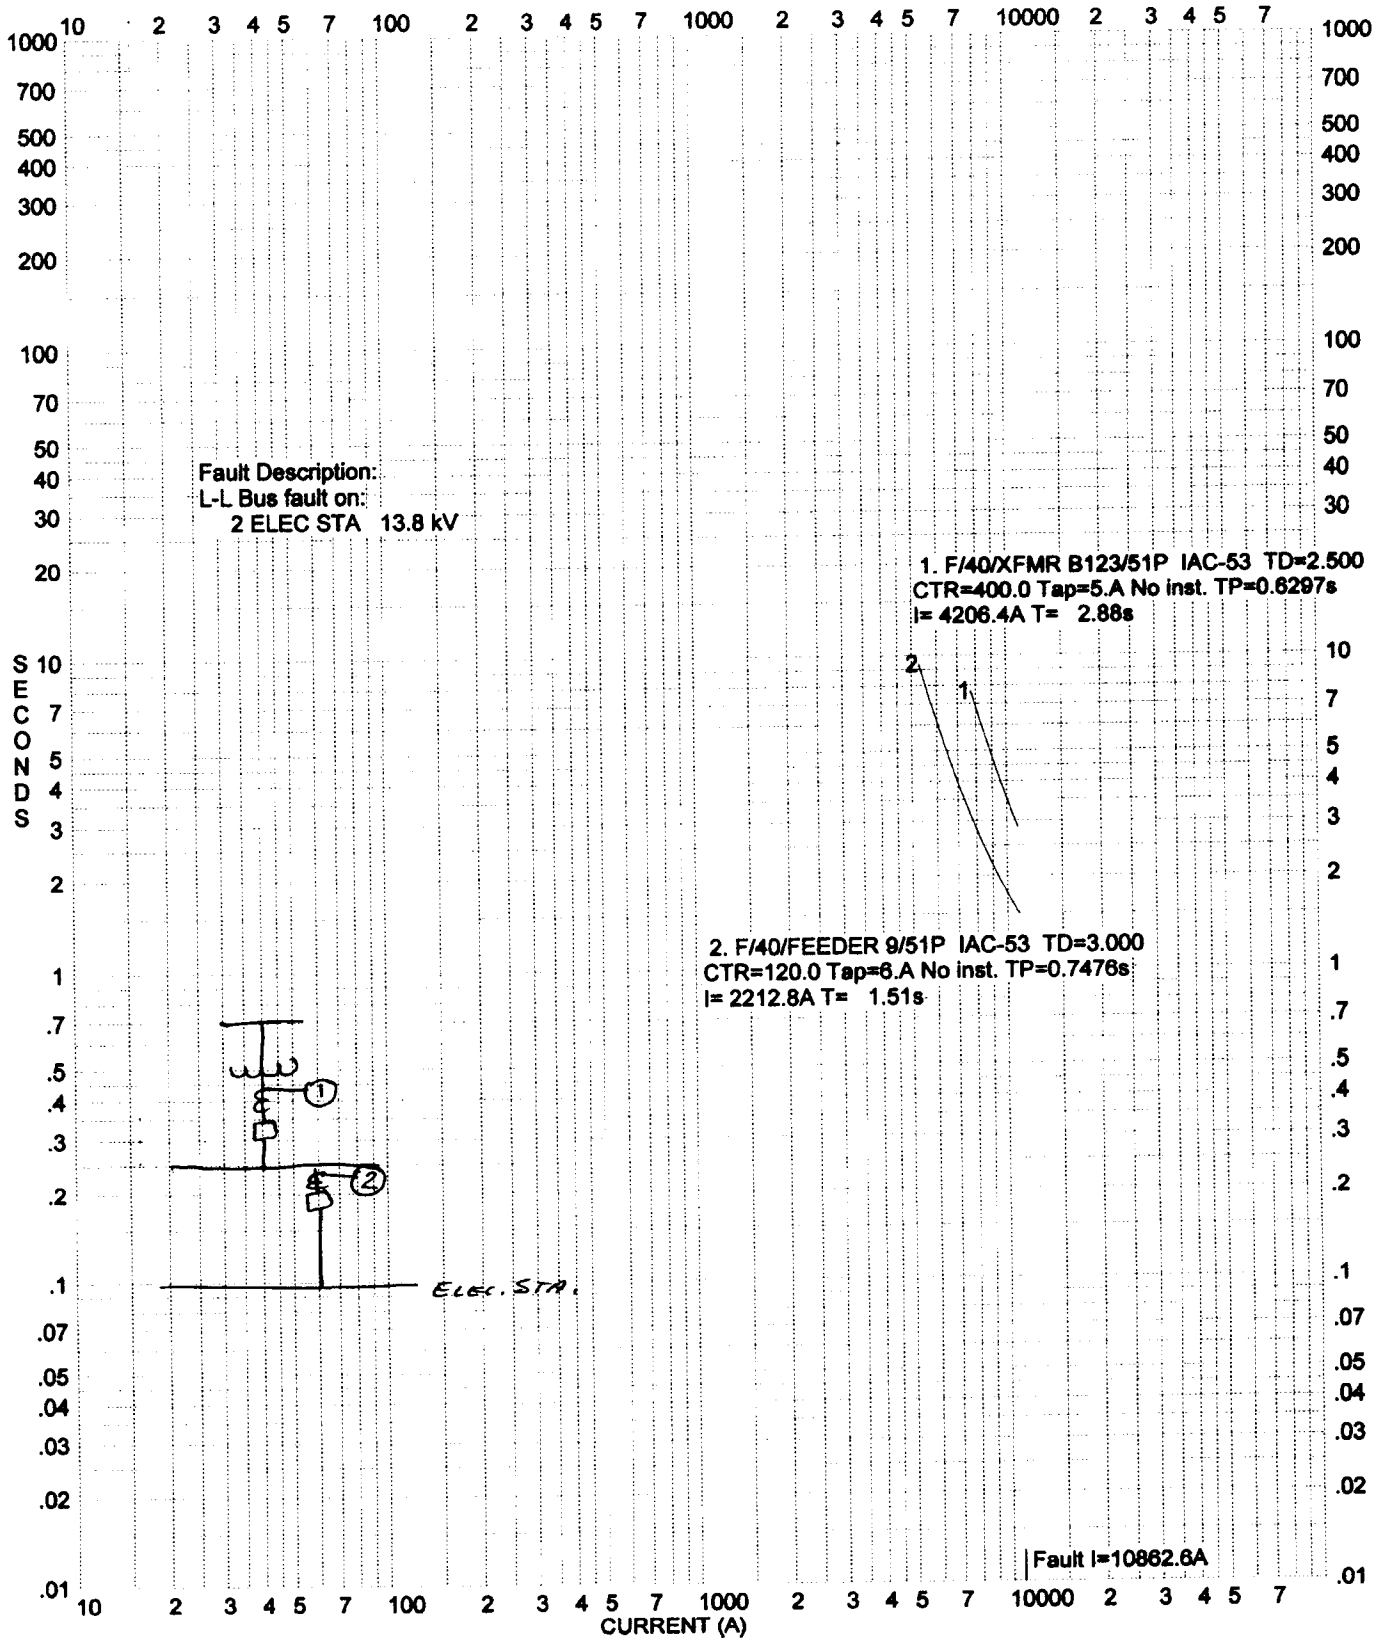
TIME-CURRENT CURVES @ Voltage 13.8kV		By	JJB
For	Coordination between Feeder 9 and Transf. Phase OC at Summer St.	No.	4 Present
Comment	Coordination Exists	Date	3/18/00
